# Manhole Inspection Summary

Manhole # S17I\_\_007MH

Insp Date: **2/27/08 8:12 AM**

**Location** Address: **2538 booth st**

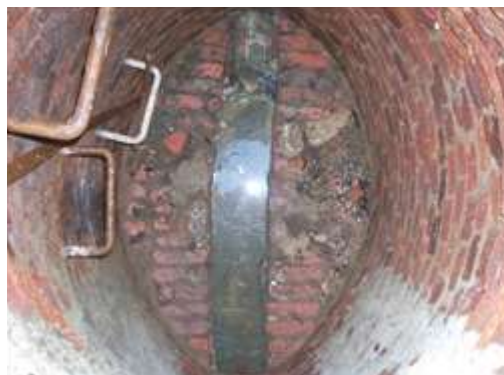
Top View

Condition: ☐ Sound ☐ Cracked ☐ Root Intrusion ☒ **Loose Brick** ☒ **Deteriorated**

Infiltration: ☐ None ☒ **Joint** ☐ Cracks ☐ Mortar ☐ Roots ☐ Wall
